Aviation Investigation Preliminary Report

Location:	Truckee, CA	Accident Number:	WPR24FA119
Date & Time:	March 30, 2024, 18:37 Local	Registration:	N960LP
Aircraft:	Daher TBM700	Injuries:	2 Fatal
Flight Conducted Under:	Part 91: General aviation - Personal

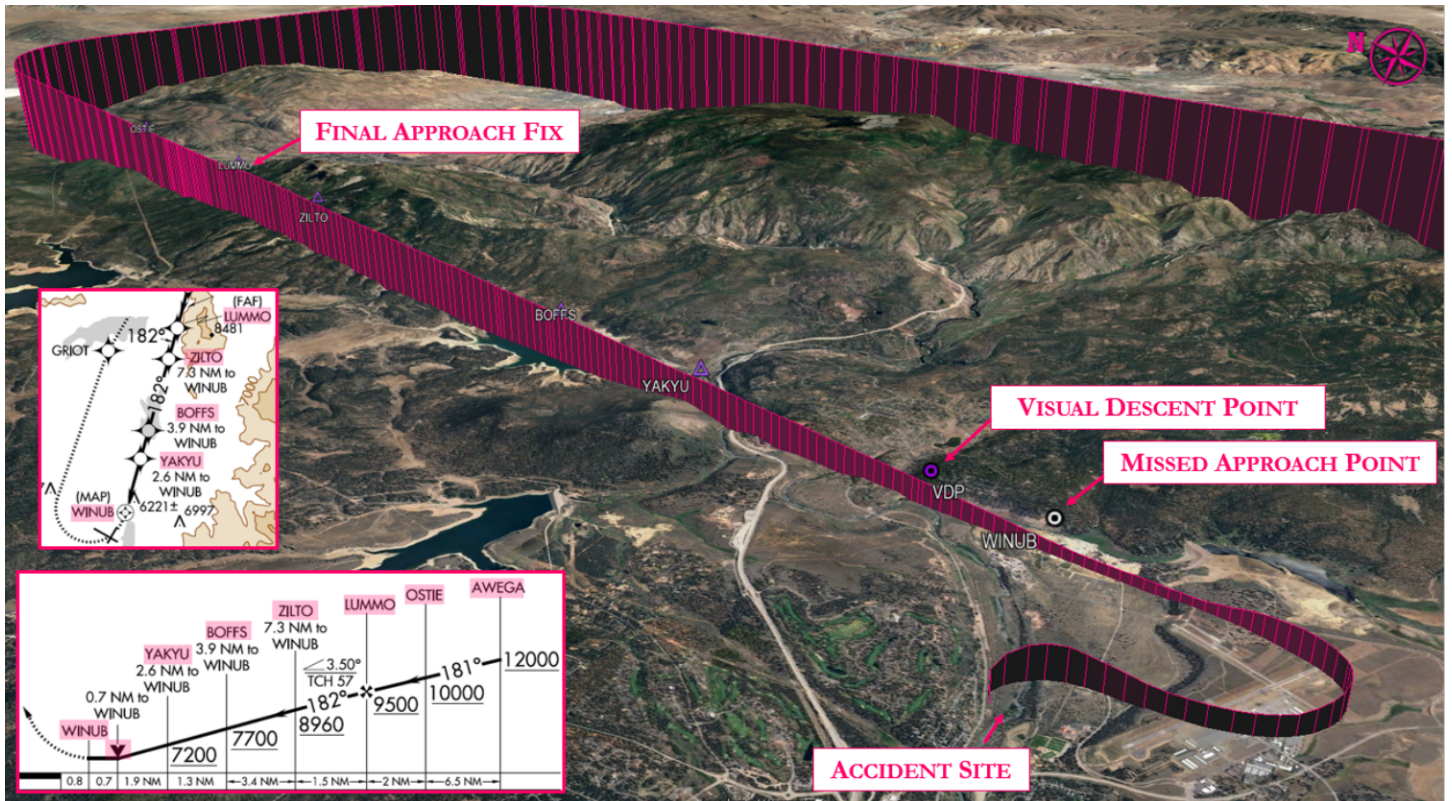
Figure 2: ADS-B Flight Track Referencing the Approach Procedure

The airplane passed over the Final Approach Fix (FAF), LUMO, at 1832:37 and the ADS-B data showed that immediately thereafter the Approach Mode (APP Mode) was turned on and the Altitude Hold (ALT Hold) was turned off. The airplane continued along the approach path and continued to descend. The flight track then passed over the Visual Descent Point (VDP) at 1835:43 at about 121 kts and an approximate altitude of 6,475 ft msl (see Figure 2 below). Approximately 20 seconds later, the track passed over the Missed Approach Point at an altitude of 6,200 ft msl and at 100 kts (total inertial speed) and continued between that altitude and 6,100 ft until abeam the runway identifier numbers (about 1,300 ft east).
